SERMA TECHNOLOGIES

**HAMAMATSU PHOTODIODES (DPD-S8576)
EVALUATION REPORT
(GLAST Project)
REPORT E01P1435 - JUNE 2002**

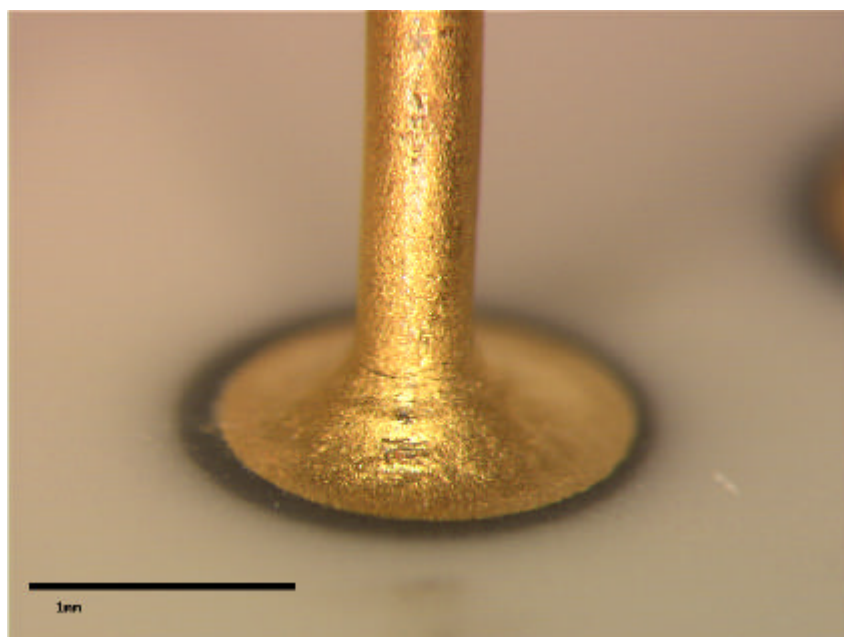
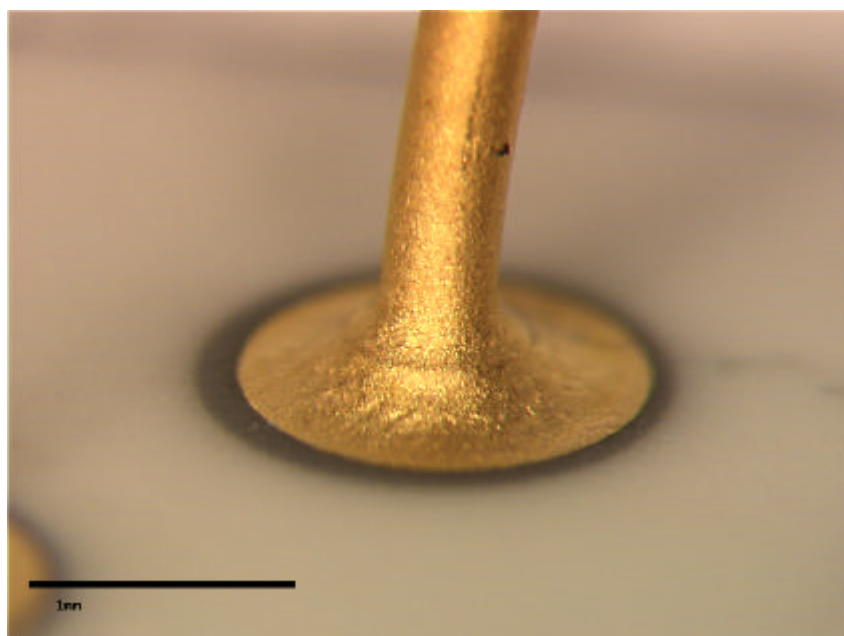
No significant degradation was found after the test. The part is acceptable (Figures 1 to 3).

Figure 2. Optical views of lead bases after bending test, $\approx 36X$.
